Injury Potential Testing of Suited Occupants During Dynamic Spacecraft Flight Phases

Shane M. McFarland¹

MEI Technologies/NASA-JSC, Houston, Texas, 77058

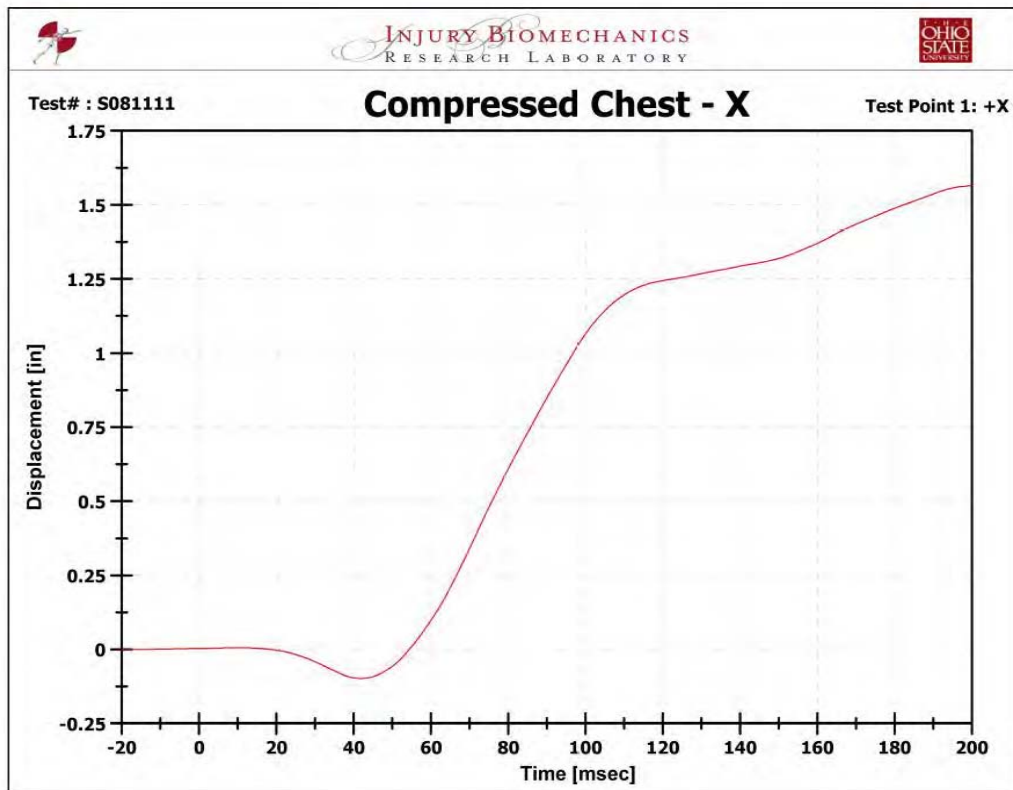
Figure 9: Test Point 1 (Subject A) Chest Compression

- The peak acceleration for the sternum was 25 g in the x-axis. This was not surprising given the motion of the event in the +X direction.
- The x-axis acceleration of T8 was similar in the range of 18 g.
- The compression of the sternum in relation to T8 in the x-axis direction was calculated using the motion blocks, Figure 9. The maximum value recorded during the event is approximately 1.57", a value below the injury threshold for the thorax used in car safety testing.

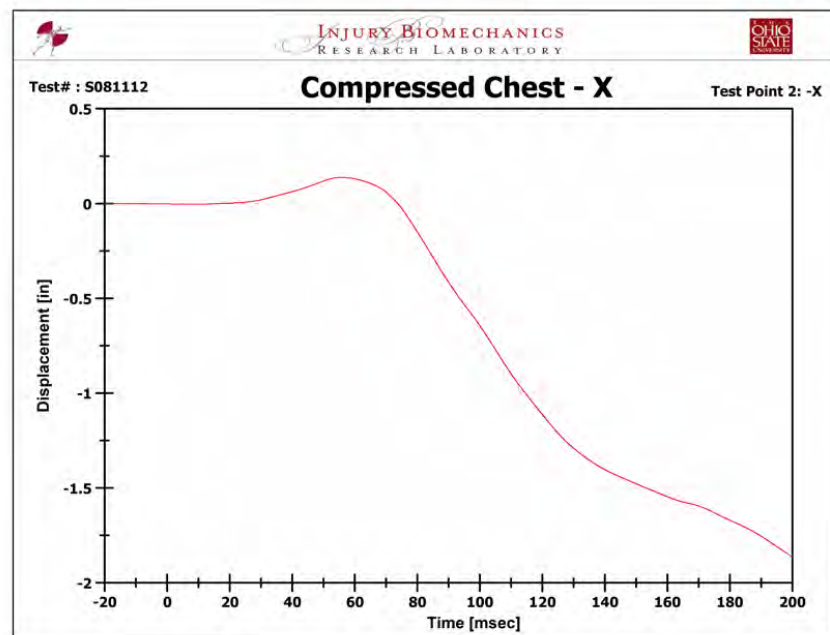
Figure 12: Test Point 2 (Subject B) Chest Compression

- The peak acceleration for the sternum was -35 g in the x-axis. This was not surprising given the interaction of the subject and the harness during the -X axis event.
- The x-axis acceleration of T8 was similar in the range of -27 g.
- The compression of the sternum in relation to T8 in the x-axis direction was calculated using the motion blocks, Figure 12. The maximum value recorded during the event is approximately 1.57”, during the initial 200 msec of the event. The compression cannot be calculated accurately beyond this time due to mathematical error introduced when integrating accelerometers into displacements.

- Humerus – No Damage
- Scapula – No Damage
- Clavicle – No Damage
- Sternum – No Damage
- Ribs
 - Left Side
 - *Disarticulation fractures of 2, 3 & 4 at the costochondral joint*
 - *Fracture at mid-axillary line of rib #3*
 - Right Side
 - *Disarticulation fractures of 3, 4 & 5 at the costochondral joint*

The multiple rib fractures on both sides of the thorax equate to an abbreviated injury score (AIS) of 450240.4, which is considered to be a severe injury. Upon removal of the thoracic plate, no further damage was documented to the lungs, heart or great vessels. The injuries sustained to this subject are due to the interactions between the scye bearings, the 5-point harness and the occupant. Based on the acceleration levels recorded at the sternum and T-8 and the thoracic compression measured during the event, past testing with an occupant restrained by a 5-point harness tells us this subject should not have been injured. It was determined that more testing in this configuration should be conducted to examine this injury mechanism further.

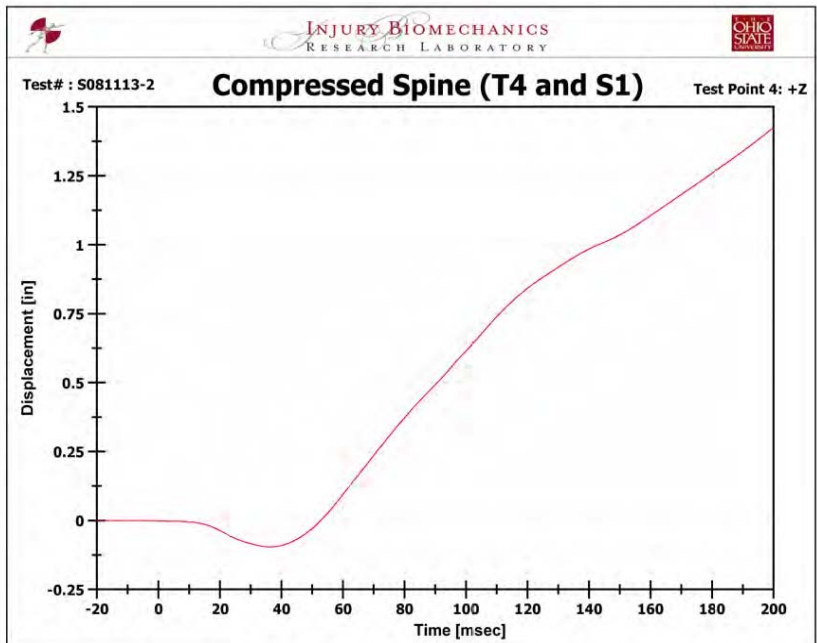
Figure 15: Test Point 3 (Subject C) Spinal Compression

- The peak acceleration for the spine was 19 g in the z-direction at the T-12 vertebra. The z-axis accelerations for T-4 and S-1 were similar at 18 g and 16 g respectively.
- The spinal accelerations were less than what was recorded in the +z-axis testing.
- This acceleration led to a spinal compression of only 0.12", Figure 15. The compression cannot be calculated accurately beyond this time due to mathematical error introduced when integrating accelerometers into displacements.
- Typically, 0.12" of spinal deflection would not equate to serious spinal injury.

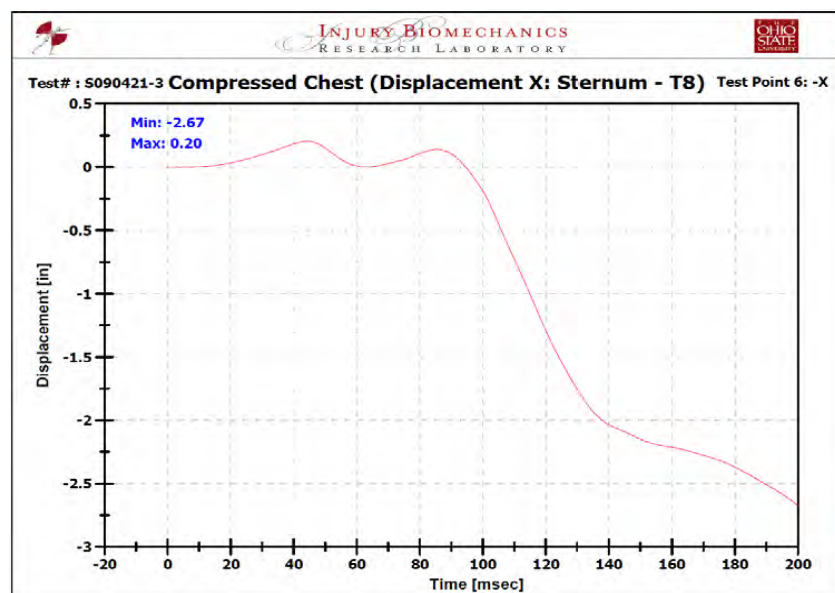
Figure 19: Test Point 6 (Subject E) Chest Compression

- The peak acceleration for the sternum was -28 g(s) in the x-axis. This was not surprising given the interaction of the subject and the harness during the -X axis event.

- The x-axis acceleration of T8 was similar in the range of -25 g(s).
- The compression of the sternum in relation to T8 in the x-axis direction was calculated using the motion blocks, Figure 19. The maximum value recorded during the event is approximately 2.25”, during the initial 200 msec of the event. The compression cannot be calculated accurately beyond this time due to mathematical error introduced when integrating accelerometers into displacements. The peak acceleration for the sternum was -35 g in the x-axis. This was not surprising given the interaction of the subject and the harness during the -X axis event.

- Humerus – No Damage
- Scapula – No Damage
- Clavicle – No Damage
- Sternum – No Damage
- Ribs
 - Left Side
 - *Non-displaced fracture on the pleural surface, 5.12” from the midline*
 - *The fracture was not evident on the cutaneous surface*
 - Right Side
 - *Non-displaced fracture on the cutaneous surface, 6.69” from the midline (mid-axillary line)*

The multiple rib fractures on both sides of the thorax equate to an abbreviated injury score (AIS) of 450210.2. Upon removal of the thoracic plate, no further damage was documented to the lungs, heart or great vessels. The injuries sustained to this subject are injuries similar to those documented in the –x-direction test with subject B. This subject’s AIS score is slightly less than documented with subject B, but the three rib fractures on both sides of the thorax would still be very painful and debilitating to occupants trying to escape a capsule.

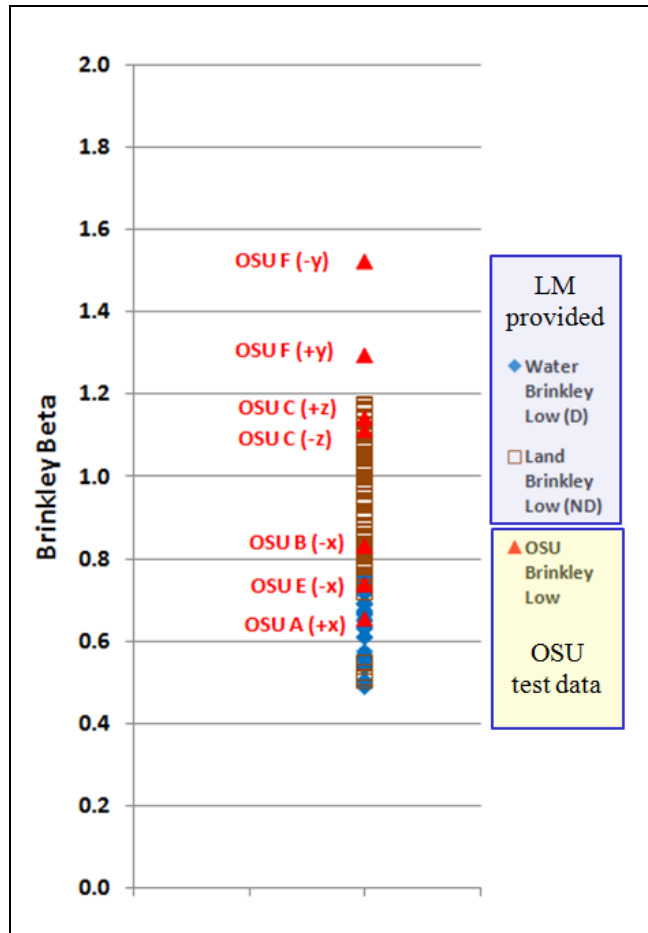
Figure 25: Landing Load Comparison

The result of this comparison is shown in Figure 25: Landing Load Comparison. In this figure, a beta (low) value of less than or equal to 1.0 correlates to less than a 0.5 percent risk of injury; while a beta value (low) of more than 1.0 correlates to a 5 percent risk of injury.

As shown in the graph, the Brinkley beta (low) values of the OSU test cases ranged from 0.6 to 1.5, correlating to a 5 percent (Y test cases) or a 0.5 percent (all other test cases) risk of injury. With the exception of the Y cases, all OSU landing loads were commensurate to landing loads currently estimated by Orion.
